HomeChek Inspection Report

Prepared Exclusively for
John Smith

Inspection Date
09/21/2006.

Re 1234 33rd Street.
Atown ,WA,98221.

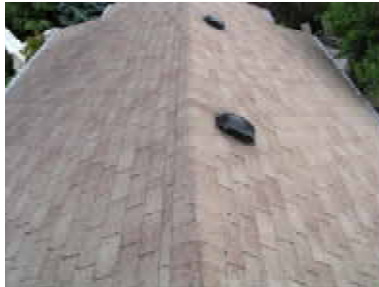
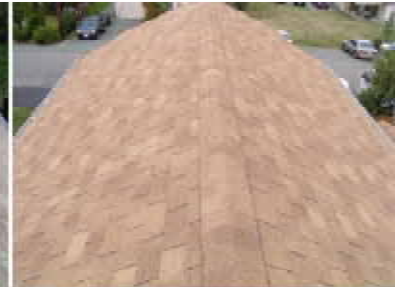
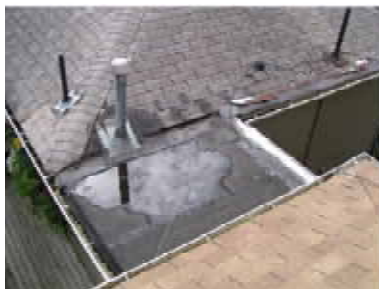
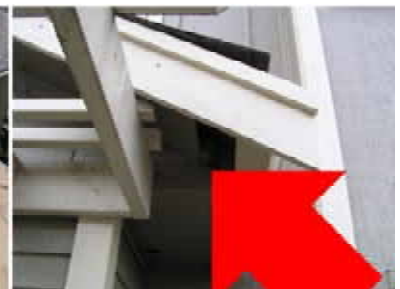
ROOF COVERING STATUS:
The roof over main home was in good condition. The flat roof over breezeway allowed water to pool and was leaking at the water heater vent. The roof on the garage was at end of life with burn through in multiple areas. Recommend that The breeze way and garage roofs be replaced. 2) The eave was not complete on the front left side of home. The opening allows birds and rodents an area for nesting. Enclose eave.

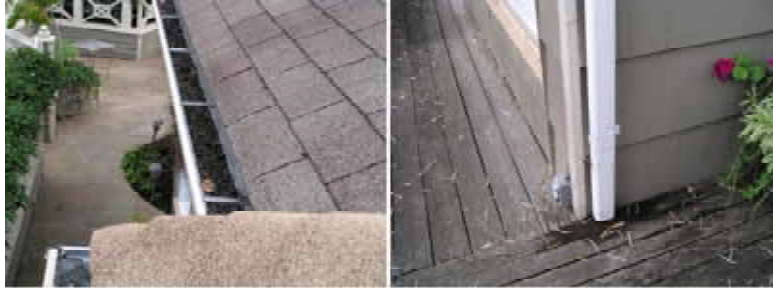
Complete installation and appears to be in satisfactory condition. Significant amounts of debris have accumulated in one or more gutters. This is a conducive condition for wood destroying insects since gutters may overflow and cause water to come in contact with the roof structure or make water accumulate around the foundation.

Recommend cleaning gutters now and on a regular basis in the future. In the Pacific NW some gutters will have to be cleaned on a quarterly basis for them to work effectively. If this is the case here, you may want to upgrade the gutters with debris covers. 2) Downspout at guest house should be extend to drain away from deck and foundation.

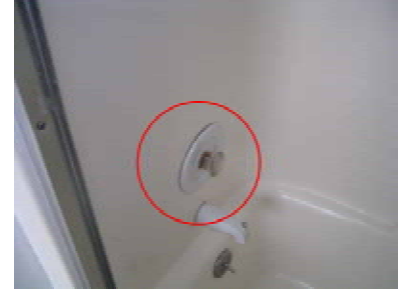
Appears serviceable. Guest room shower fixture should be caulked to prevent water intrusion.

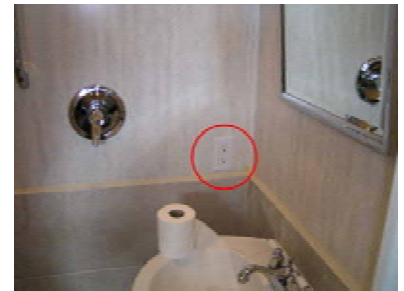
Bath GFI

The guest room bath technically is a shower stall and should not have an exposed outlet in it. Protect with weatherproof cover or remove.

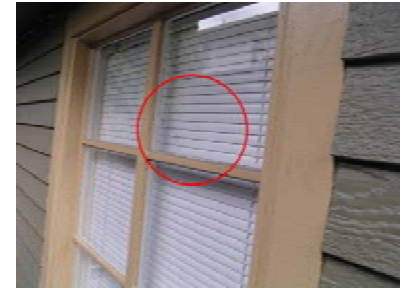
Vinyl windows, Wood, cracked window in guest house.
