# Inspection Report

123 Anacortes Place

Inspection Date  
12/10/06

Re: 157 9th St.  
Anacortes, Washington

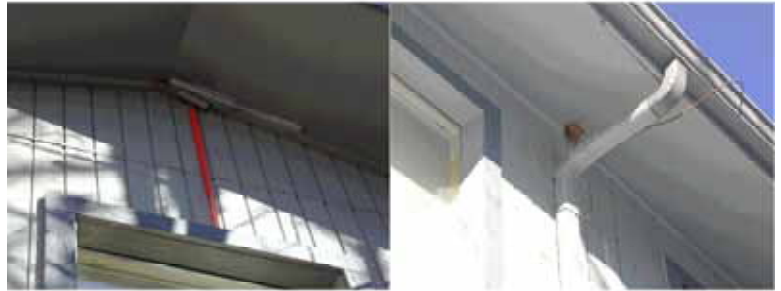
There appears to be numerous areas where birds or possibly rodents have penetrated the wood sheeting. Some areas have been sealed with sheet metal and other are still open. See pictures.

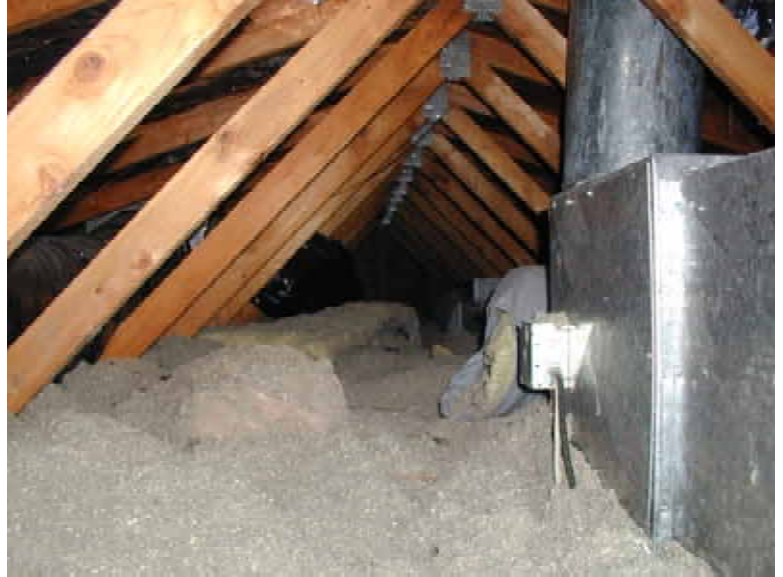
Viewing was limited, to observing from hatch areas only. Access was limited by shelving in closet area goods.

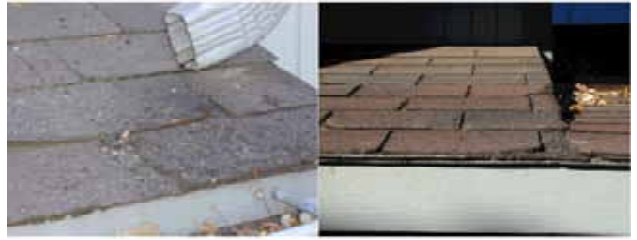
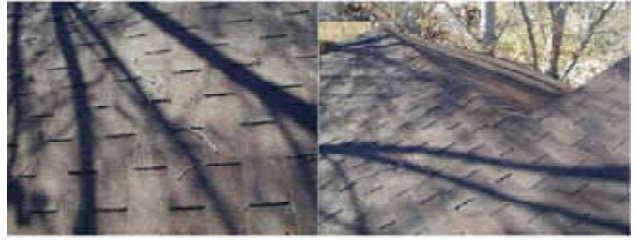
Porch, shed and SW corner of roof

There appears to be three generations of shingles on the house. The original shingles such as on front porch and SW corner appears to be original, roofing on NE (front) portion of the roof is approximately 10 yr. old and on the SE portion of the roof was installed recently. Asphalt or fiberglass roofing shingles generally have service lives of 10-12 years and 12-15 years respectively in this area of the country. Heavy duty shingles will often last 15 to 18 years before replacement is needed. Signs of aging include brittleness, minor curling, and loss of mineral granules, while signs of advanced aging are severe curling, broken or split shingles, and exposed felts. The porch, shed and SE corner shows signs of advanced aging (see pictures)

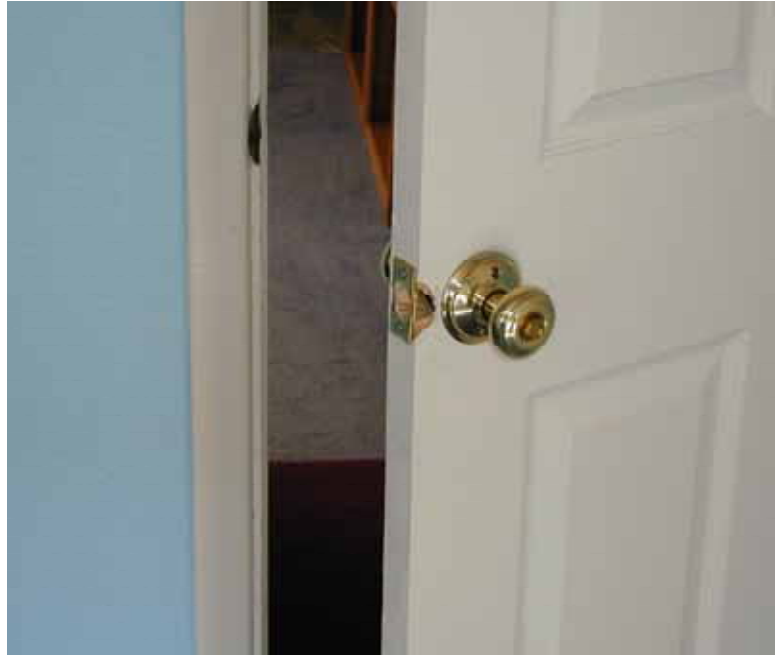
Bedroom #3 Bolt and striker are damaged.

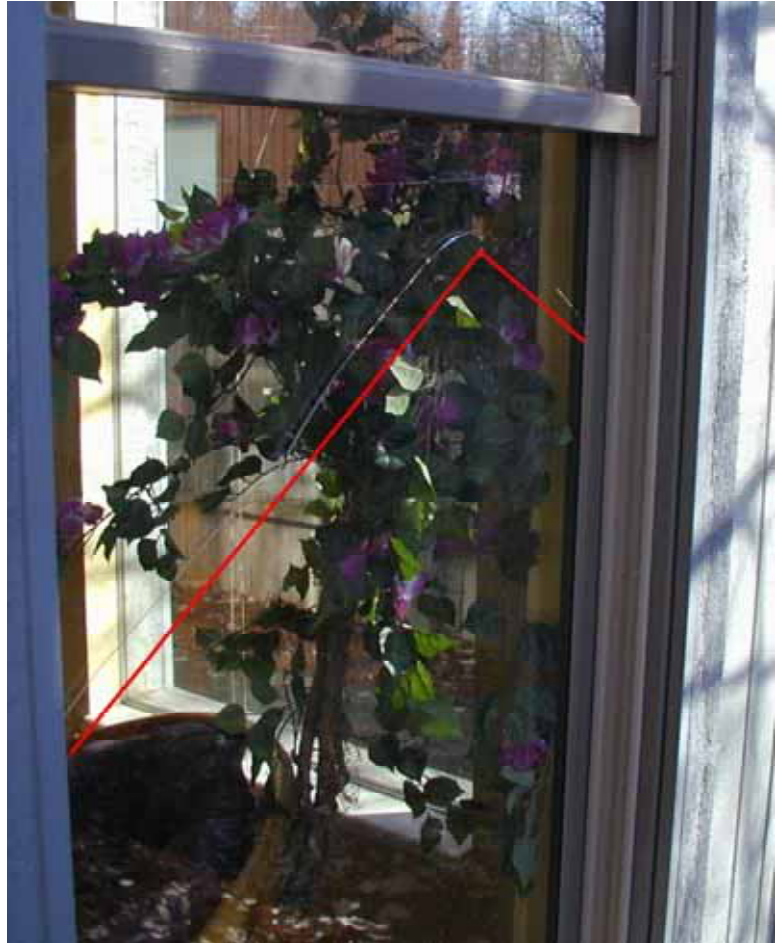
All in good shape. Window in rear is cracked.

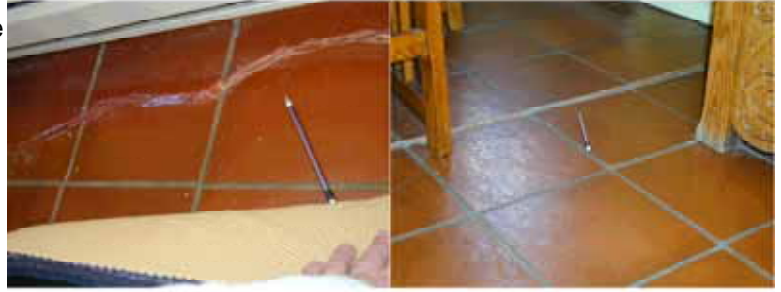
Carpet, Wood, Tile. Tile in Sunroom has running crack approximately 5ft. long. This appears to be from settling in that area of the floor.

**Crack and Raised Edge**

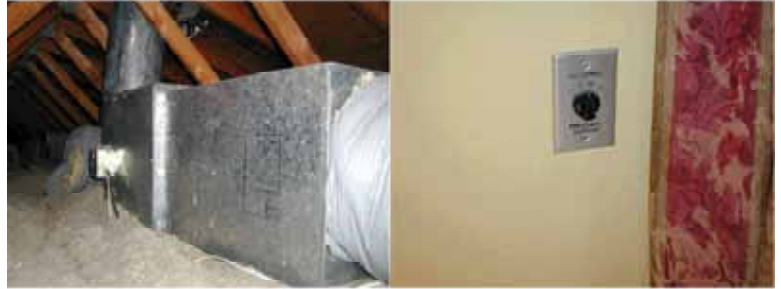
Unknow type of air handling unit in attic.  
Have the sellers disclose the purpose of system and demonstrate the proper operation of this component prior to taking possession of the property.

McQuay Air handler ????

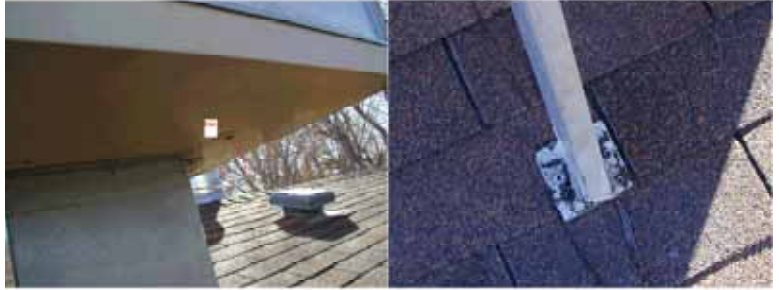
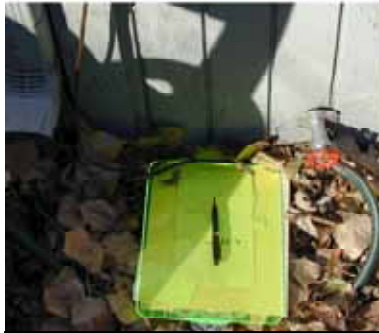
Swamp Cooler legs need to be attached and caulked to prevent roof leak. Drain line is missing and needs to be routed to a drain to avoid damage to shingles. Water supply line appears to be a temporary connect to spigot. It is recommended that a permanent connection be made.

Missing drain line, unattached leg, Water

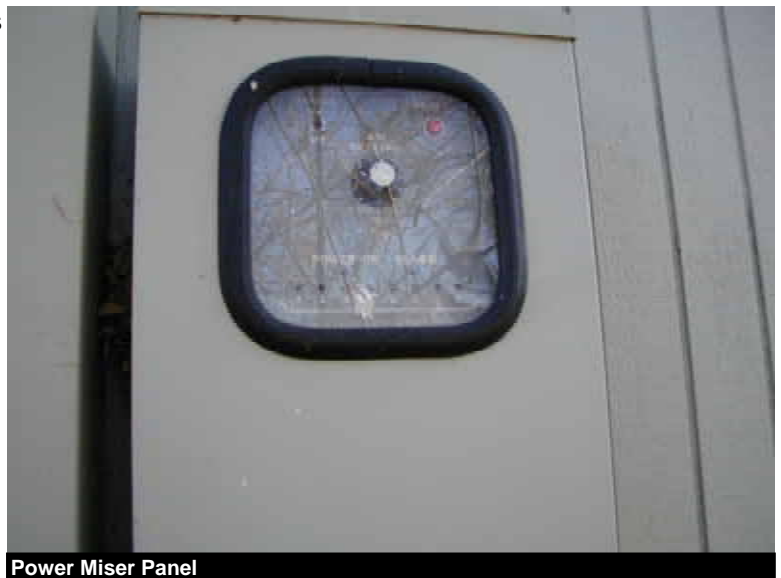
Power Miser Panel

System has power miser controller. This was probably installed when house was built. Check with owners to see if it is still operational. Appears to control baseboard heaters.

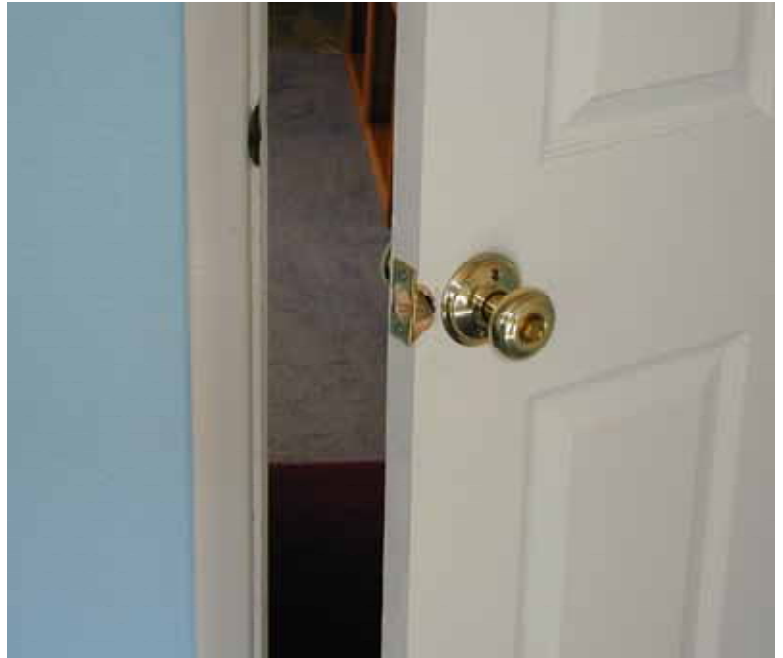
Damaged.

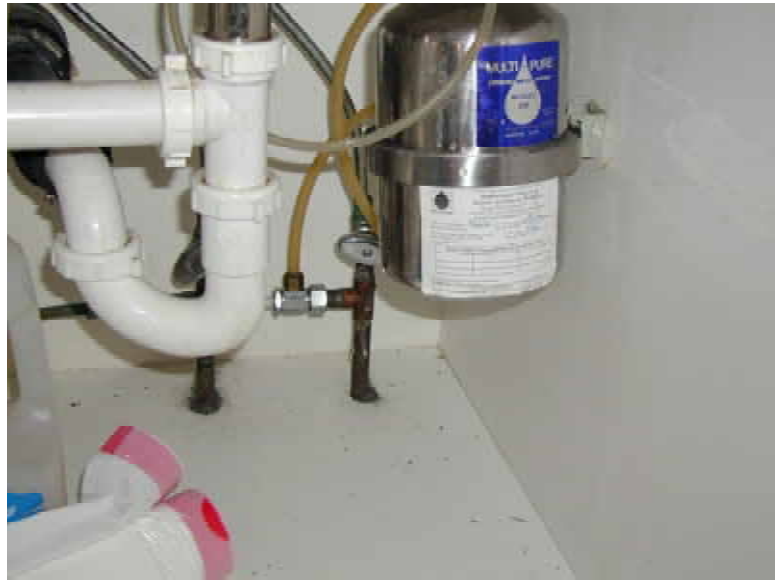
Water Filter - according to label filter should have been changed in August 2002. Suggest cleaning/changing filter for most efficient operation.
