Inspection Report

123 Anacortes Place

Inspection Date

12/10/02

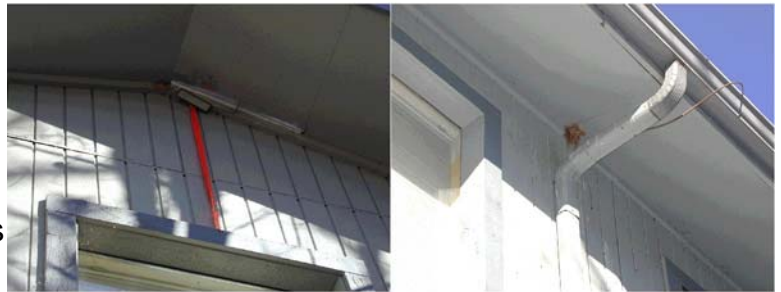
There appears to be numerous areas where birds or possibly rodents have penetrated the wood sheeting. Some areas have been sealed with sheet metal and other are still open. See pictures.

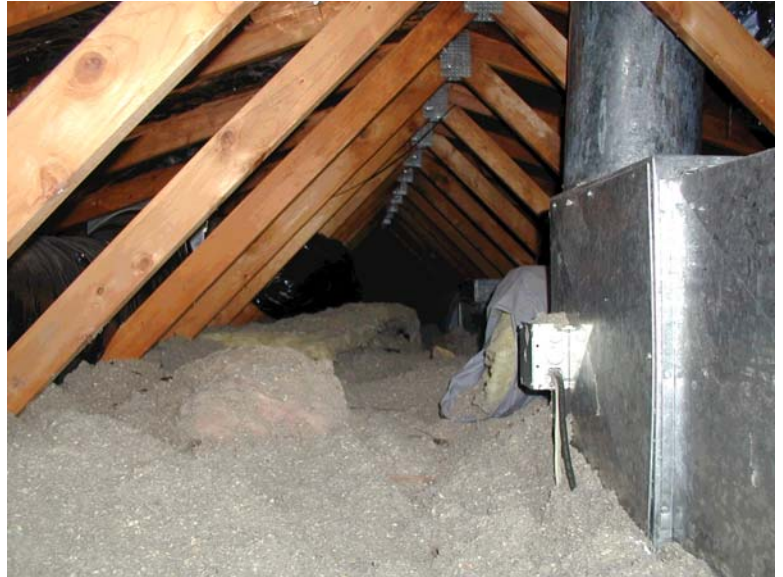
Viewing was limited, to observing from hatch areas only. Access was limited by shelving in closet area goods.

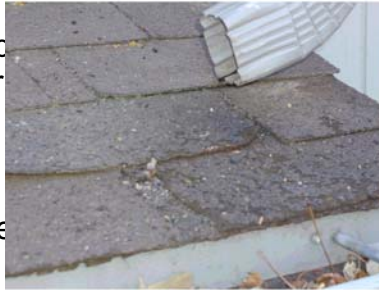
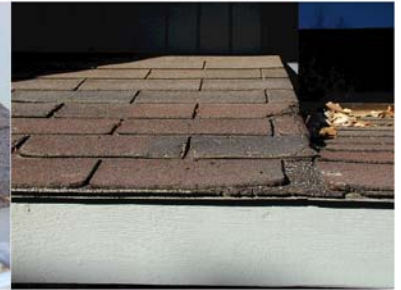
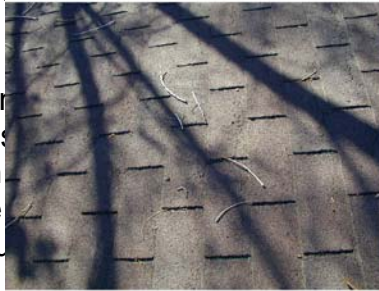
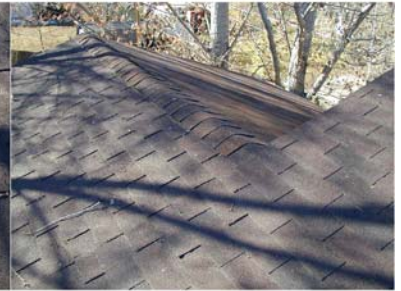
The Porch, shed and SW corner of roof

The re app ear s to be thro e ger era tion s of shir gles on the hou se.

orig inal shingles such as on front porch and SW corner appears to be original, roofing on NE (front) portion of the roof is approximately 10 yr. old and on the SE portion of the roof was installed recently. Asphalt or fiberglass roofing shingles generally have service lives of 10-12 years and 12-15 years respectively in this area of the country. Heavy duty shingles will often last 15 to 18 years before replacement is needed. Signs of aging include brittleness, minor curling, and loss of mineral granules, while signs of advanced aging are severe curling, broken or split shingles, and exposed felts. The porch, shed and SE corner shows signs of advanced aging (see pictures)

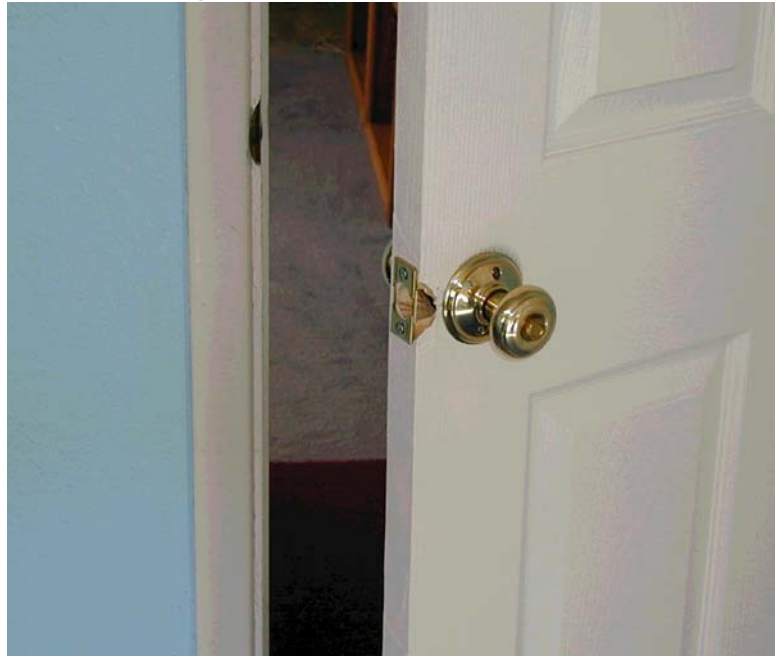
Bedroom #3

Bolt and striker
are damaged.

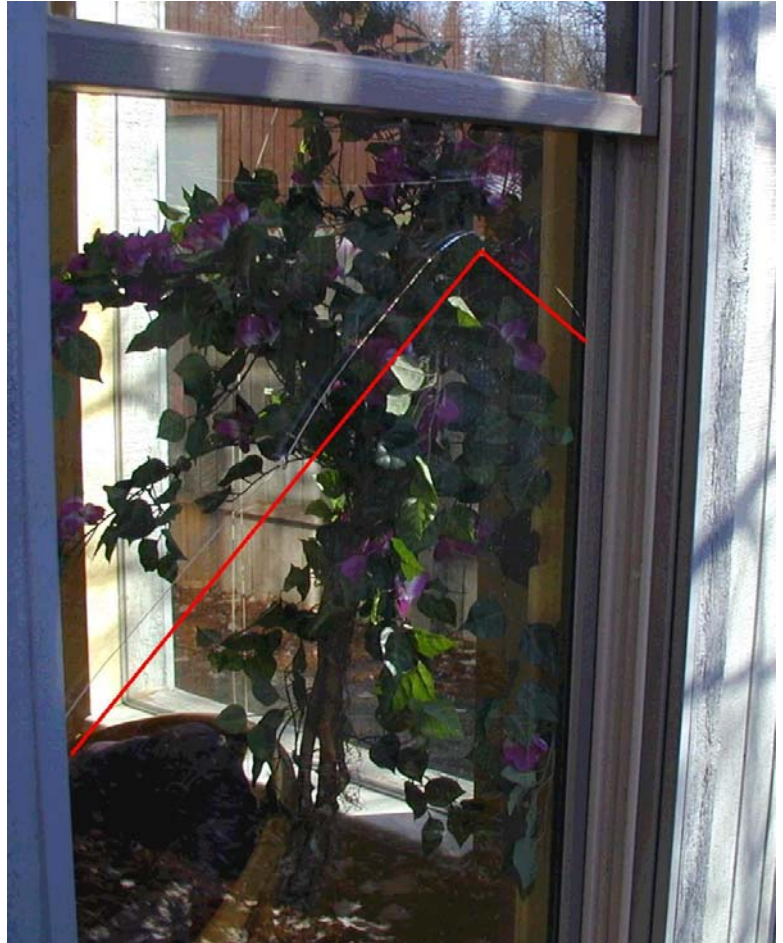
All in good shape. Window in rear is cracked.

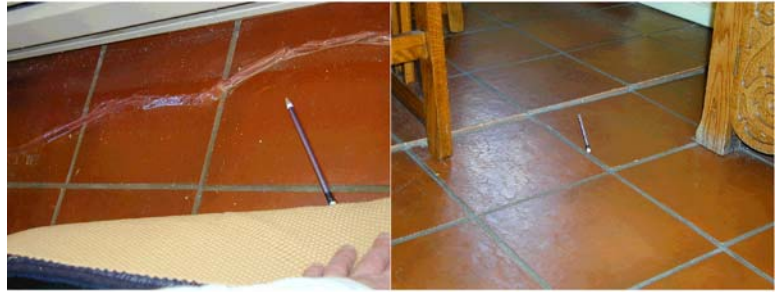
Carpet, Wood, Tile. Tile in Sunroom has running crack approximately 5ft. long. This appears to be from settling in that area of the floor.

**Crack and Raised Edge****STAIRS & HANDRAILS:****CONDITION:**

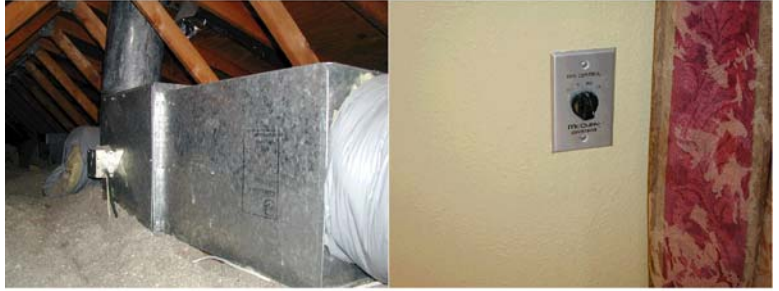
ADDITIONAL HEATING SYSTEMS: Unknow type of air handling unit in attic. Have the sellers disclose the purpose of system and demonstrate the proper operation of this component prior to taking possession of the property.

McQuay Air handler ????

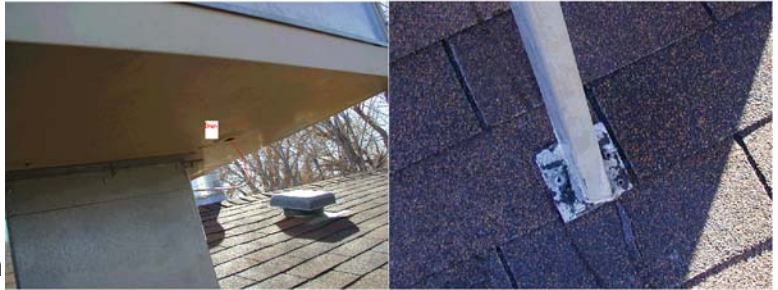
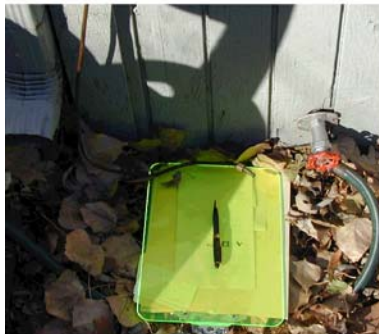
Swamp Cooler legs need to be attached and caulked to prevent roof leak. Drain line is missing and needs to be routed to a drain to avoid damage to shingles. Water supply line appears to be a temporary connect to spigot. It is recommended that a permanent connection be made.

Missing drain line, unattached leg, Water

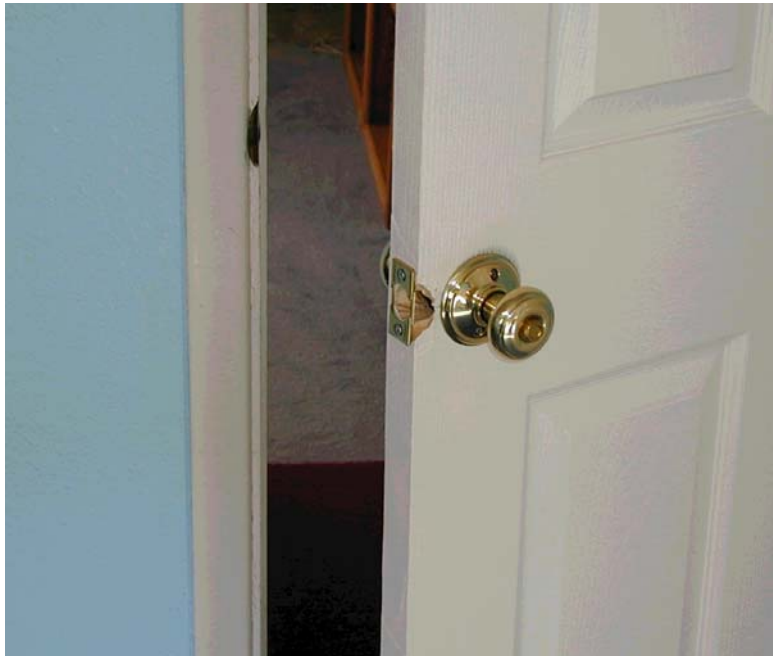
Doors	Damaged.
--------------	----------

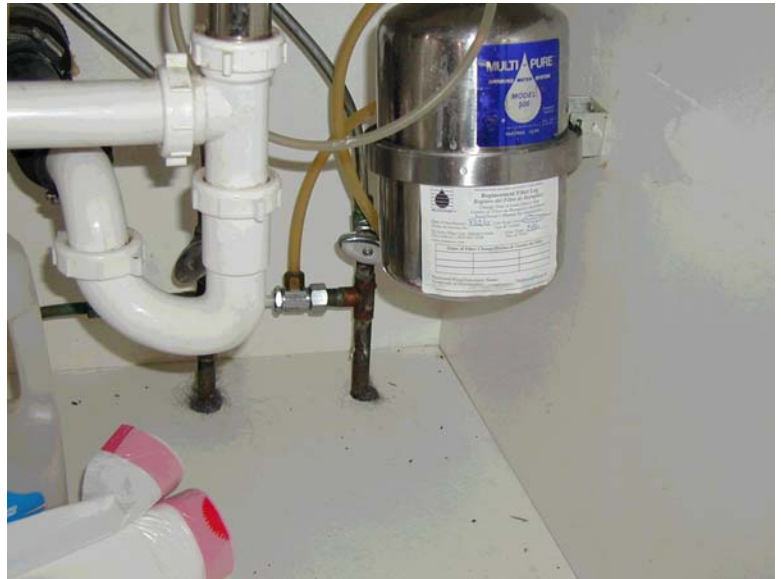
Water Filter - according to label filter should have been changed in August 2002. Suggest cleaning/ changing filter for most efficient operation.
