# Inspection Report

123 Anacortes Place

Inspection Date  
12/10/06

Re: 157 9th St.  
Anacortes, Washington

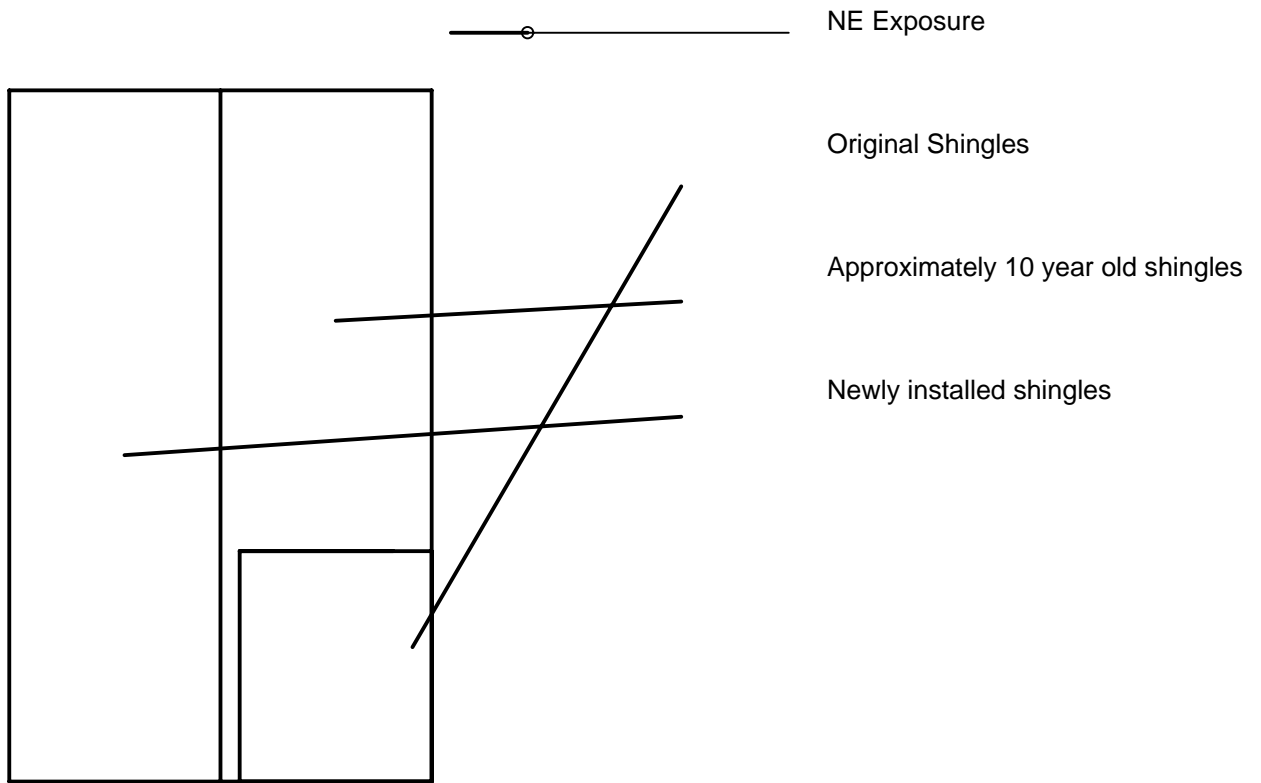
PLAN VIEW OF ROOF (not to scale)

There appears to be three generations of shingles on the house. The original shingles such as on front porch and SW corner appear to be original, roofing on NE (front) portion of the roof is approximately 10 yr. old and on the SE portion of the roof was installed recently. Asphalt or fiberglass roofing shingles generally have service lives of 10-12 years and 12-15 years respectively in this area of the country. Heavy duty shingles will often last 15 to 18 years before replacement is needed. Signs of aging include brittleness, minor curling, and loss of mineral granules, while signs of advanced aging are severe curling, broken or split shingles, and exposed felts. The porch, shed and SE corner shows signs of advanced aging (see pictures)

Porch, shed and SW corner of roof

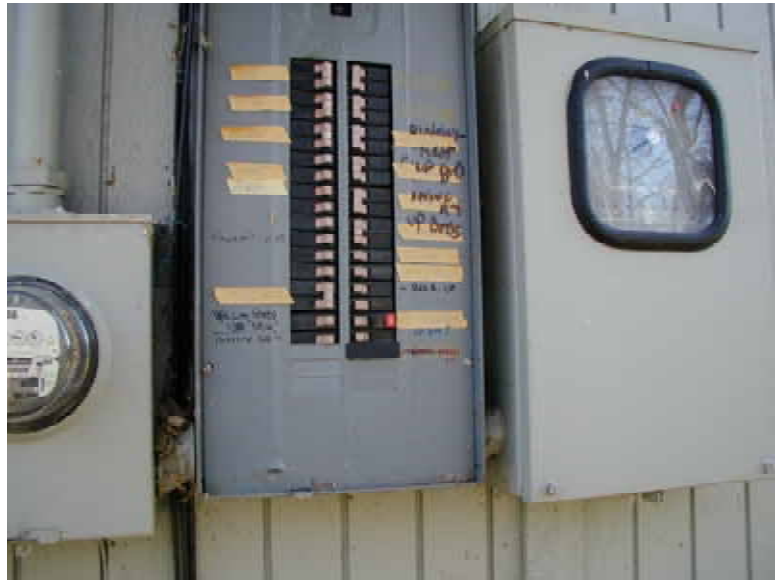
Exterior of house.

System has power miser controller. This was probably installed when house was built. Check with owners to see if it is still operational. Appears to control baseboard heaters.
