Inspection Report

123 Anacortes Place

Inspection Date

12/10/02

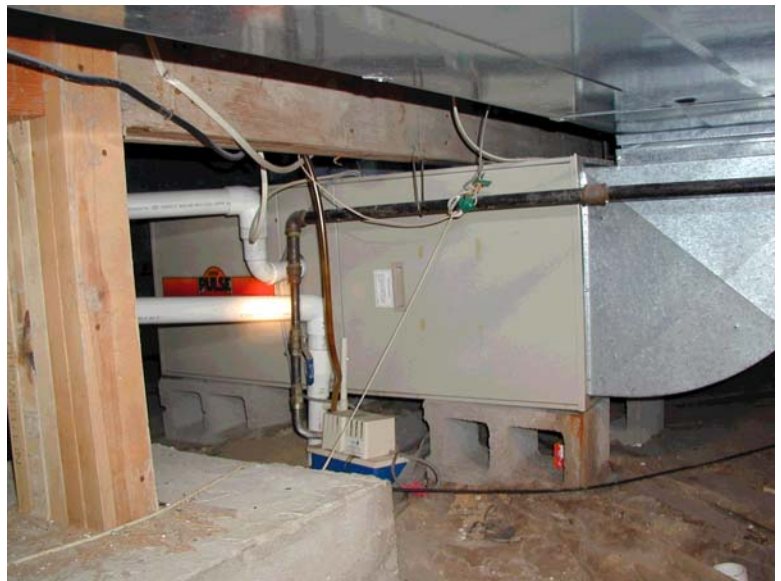
LOCATION OF PRIMARY UNIT: Crawl space.
SYSTEM TYPE: 80% to 90%
 Efficient forced air.

FUEL TYPE AND NOTES: Natural Gas.
CAPACITY OF UNIT: Unknown.
APPROXIMATE AGE IN YEARS: Unable to find label. Believe it is about 10 years old.
SECONDARY HEATING SYSTEM: Electric Baseboard.

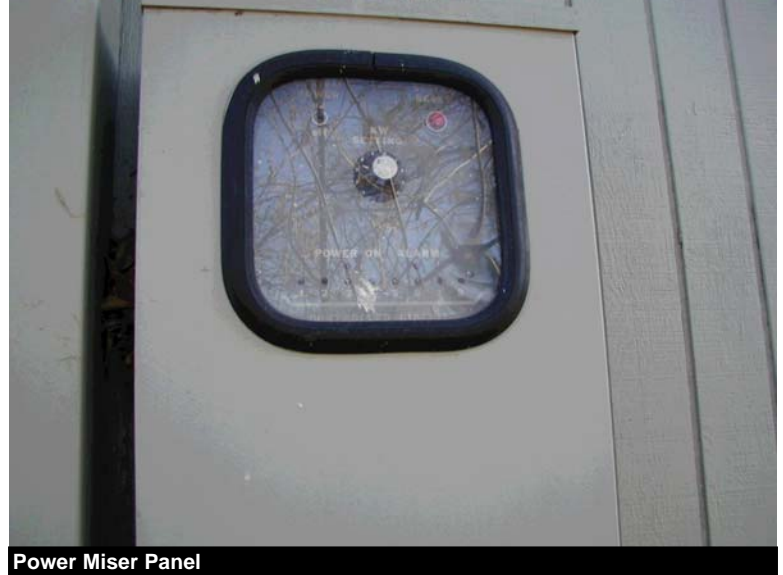
System has power miser controller. This was probably installed when house was built. Check with owners to see if it is still operational. Appears to control baseboard heaters.
